Photogrammetry for masonry bridge inspection and recording

Photogrammetric models for inspection and records

Hamish Harvey & Bill Harvey, Bill Harvey Associates Ltd.

Case study - Rutters Bridge

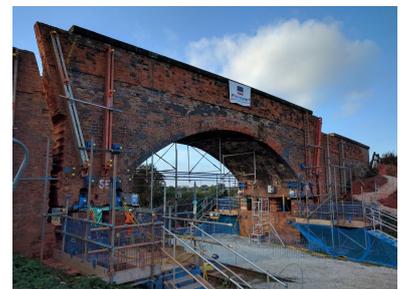
It continues to the present with the award winning ElevArch trial, a world first in which a masonry arch bridge was jacked to create additional clearance for electrification (figures 1, 2). This was an idea of Bill's, taken up by Freyssinet and developed jointly.

Figure 1: Moco Farm bridge, raised by 900mm

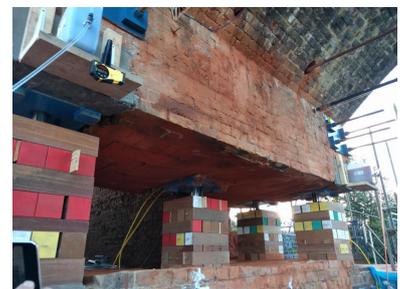
Figure 2: South abutment of Moco Farm bridge, raised by 900mm

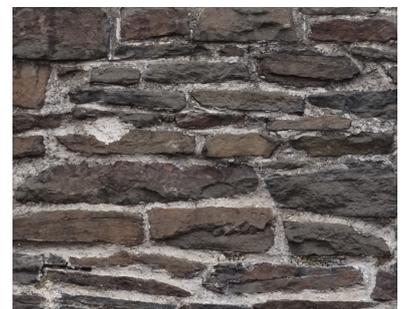
It is now possible to collect a dense set of photographs of a bridge, covering the whole surface with overlapping photos from about 2m range, and process these into a 3D model that captures every lump and bump of surface. The photographs are then projected back onto the model, giving sub-mm detail as in figure 3.

Figure 3: Large structures can be recorded in sub-mm detail.

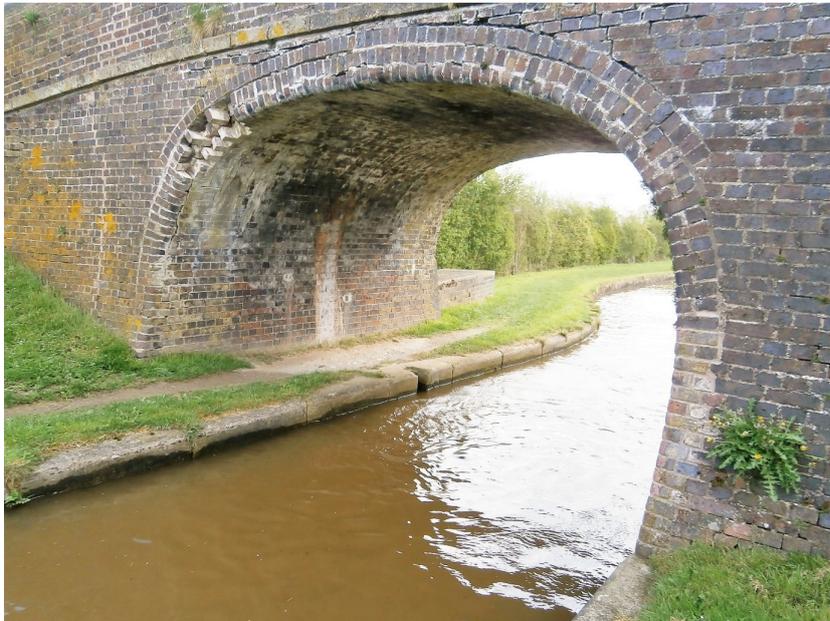
Figure 4: General view of Rutters Bridge. This is the only photograph presented in this note, all other images of Rutters bridge are model renderings.

Bill was asked about the slab over the crown, and found a chance to visit with Ian Draycott of the Canal and River Trust, to whom thanks for a very enjoyable day. Figure 4 shows a general view. Even at this distance you can see why there was concern.

Ignoring the arch for the moment, there is one very obvious vertical crack in figure 4. It looks as though it might follow the line of the back of the abutment, why else would it be so straight.

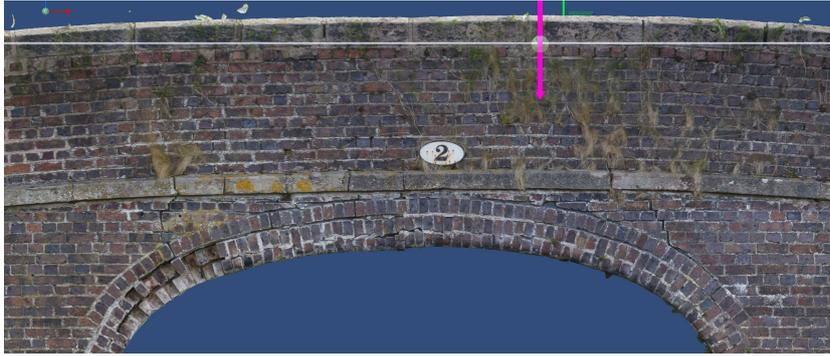
Moving the plane up to the coping (figure 11) shows that it has an almost continuous curve but it is slightly flattened in the middle, suggesting a drop over the crown.

Figure 11: Horizontal plane under coping at crown.

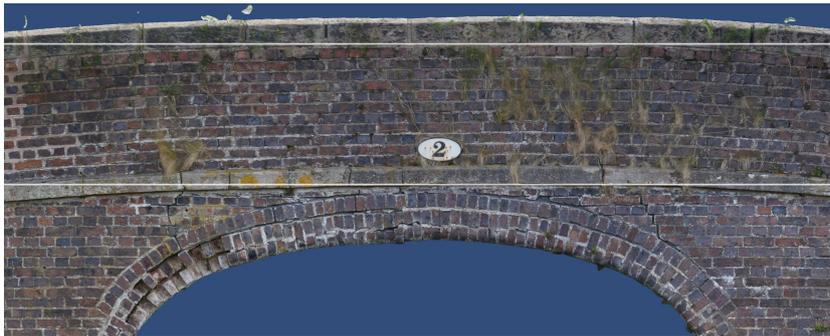
The string course also looks flat in the middle. Rather than moving the plane, we can duplicate it and move the copy off line. Putting a straight line through both places emphasises the effect (figure 12).

And here, there is more to see. Notice the crack at the right tracking down to the arch, round the back of it and then through. A hinge

Figure 12: Two parallel, horizontal planes.

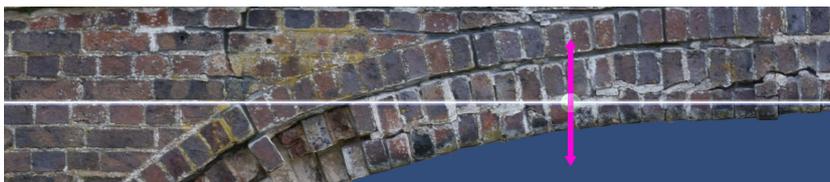
opening at the top. If there were thrust in the arch, the right hand hinge would have formed near the crown, because that marks a straight line between a top hinge and a bottom hinge (see the plane in figure 13), allowing free movement without any increase in thrust. In fact, the loose brick at the centre says there definitely isn't an intrados hinge there.

Figure 13: Plane shows that top of side hinge is on same level as crown intrados. A loose brick at the crown shows that there is no thrust at the intrados.

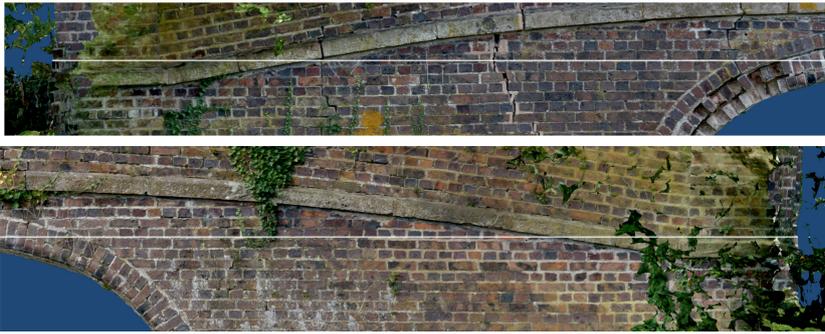
We can also switch from one side to the other. Careful examination of figure 14 shows that the abutment is lower in the first than the second: there is a cross fall. Perhaps that begins to explain why all those bricks are missing. There is still a slight fall to the back of the abutment.

Figure 14: Same view, opposite sides of abutment, with the plane unmodified, shows a cross fall in the abutment.

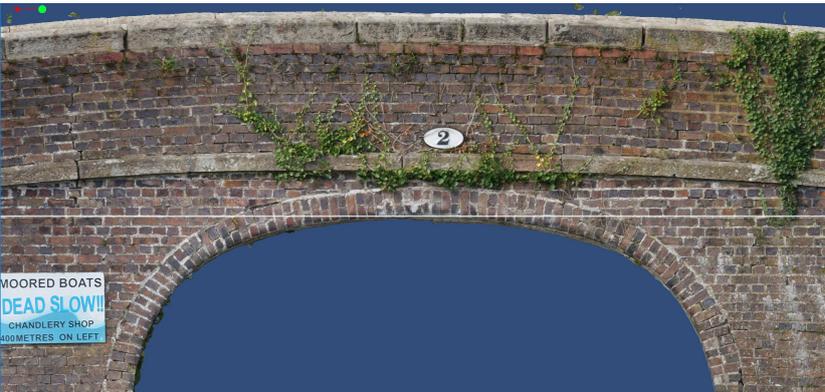
On the other elevation (figure 15), the courses are level from end to end except for a very slight back tilt at the right (the same side as the left in previous pictures).

Figure 15: The other elevation, orthophoto.

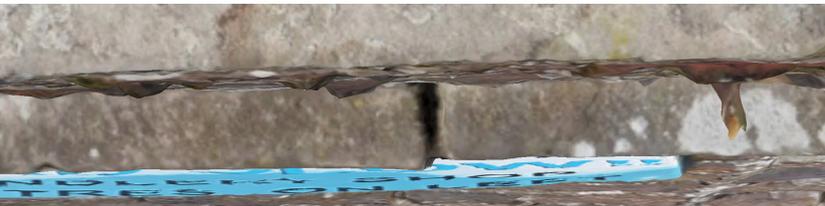
Looking down and enlarging, the crack above the SLOW sign seems to have put a plan joggle in the string course (figure 16).

Figure 16: Plan view of SLOW sign, shows a plan step in the string course.

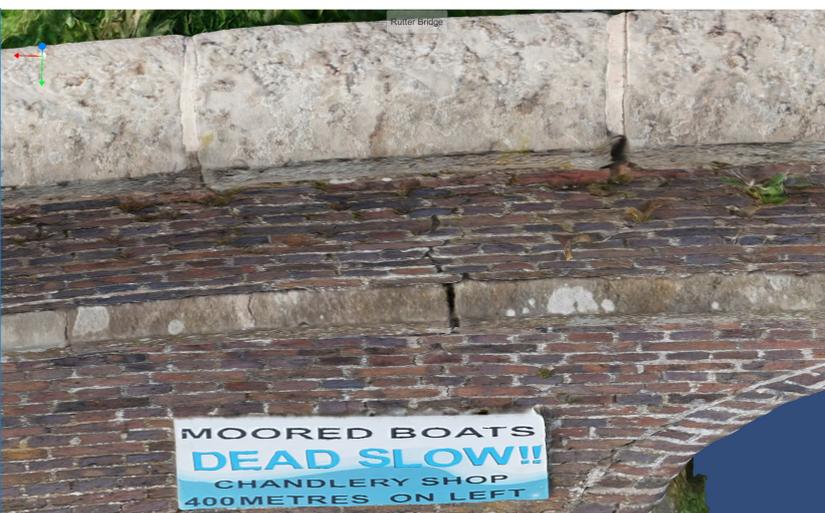
It is easier to understand that by zooming out a little (figure 17).

Figure 17: Inclined view of SLOW sign. I think that crack bifurcates and reaches both ends of the coping stone. This movement is caused by the twist in the bridge. The step is masked as a slew in a long stone at the parapet.

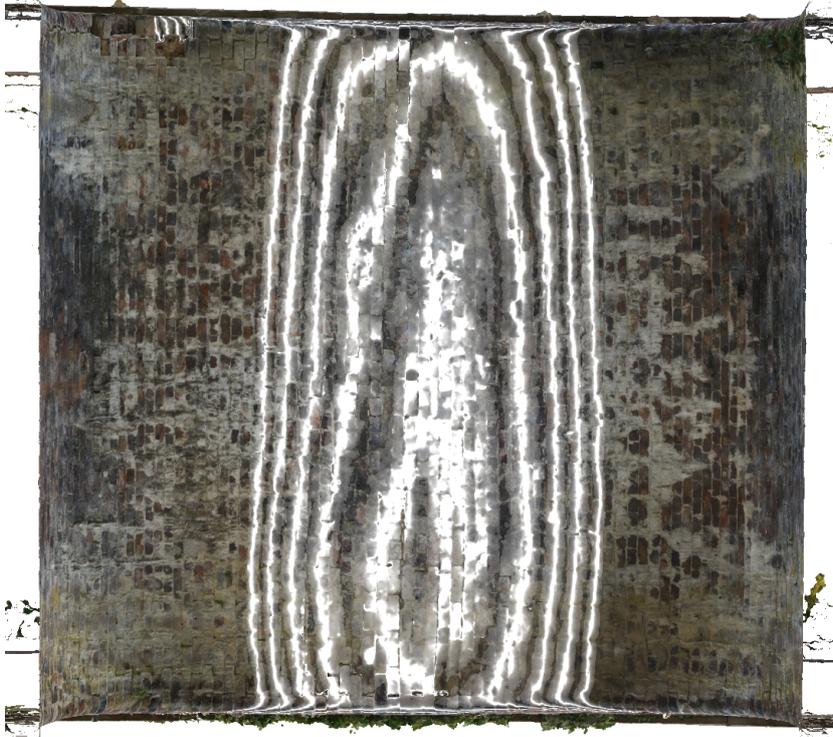
Defining a plane and manipulating it, watching the contour change in real time is a very powerful way of developing a feel for deformations. It is possible because the contours are calculated by the graphics processor. Traditional contours at equal spacing can still be valuable, not least for inclusion in a report, and are simple to produce (figure 18) by defining planes numerically (figure 19).

Figure 18: Planes can be defined numerically, making it simple to produce contours, whether in plan as here, or vs any chosen normal.

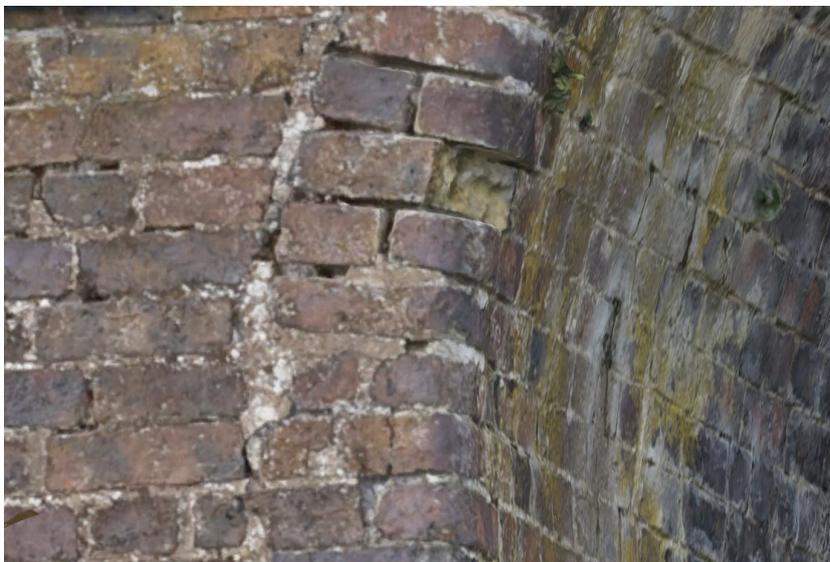
Figure 22 is a closer view of the corner. The image is getting to the limit of available resolution but the joints are still visibly tight under the arch.

Look closer at that broken nose in the arch (figure 22). It's obvious that the brick was pinched tight before it failed. The mortar was squashed to nothing at the inside edge and similarly tight joints can be seen across the arch face. That wide mortar patch round the back of the arch obviously indicates movement and where the joint runs out, the movement continues by snapping a brick.

Figure 22: Do the gaps in the corner go round under the arch? This view shows that they don't. Note wide mortar indicating movement at back of ring, tight joints on the soffit, and snapped brick at the corner.

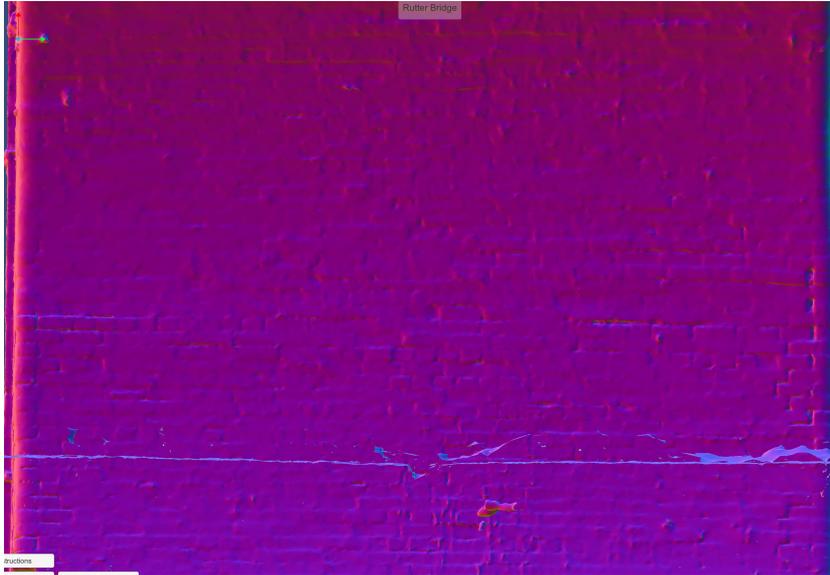
Looking at the soffit in false colour, we find initially that the tow-path interferes with the view (figure 23). We can add a cropping plane to remove it, getting figure 24.

Figure 23: Tinting every bit of surface according to the direction of its normal emphasises empty joints and other damage. Is it just me or do the colours change across a diagonal?

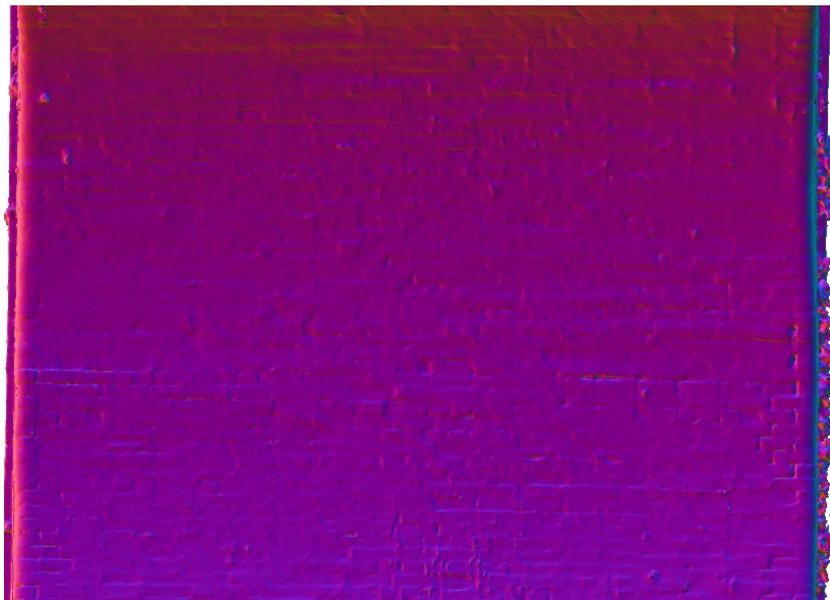
Figure 24: To clean the image a bit we put in a cut plane and removed everything below it. That takes out the ghost of the towpath edge and made things clearer. Notice the thin bright stripe where there is a drop between bricks near the crown at the left. The model is tilted here to emphasise that.

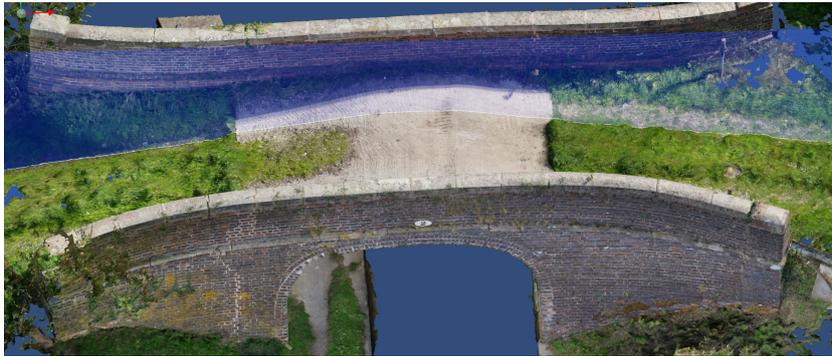
Figure 25: A vertical plane defined to pass through two points.

Another plane option is “2 point vertical”. This allows us to align a vertical plane with the bridge as in figure 25.

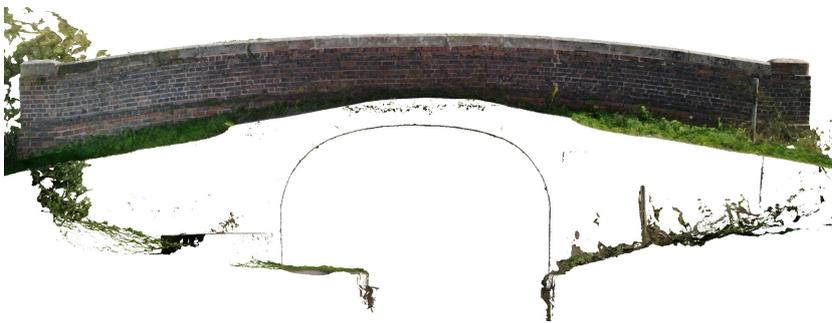
Figure 26: Setting the plane to remove everything in front and taking a square view, we can now see the huge steps onto and off that slab. It’s hard to imagine vehicles getting over that without causing trouble.

If we set that plane to crop the near side of the model away, and go to a front elevation, we get figure 26, which shows the slab surface against the backdrop of the far parapet.

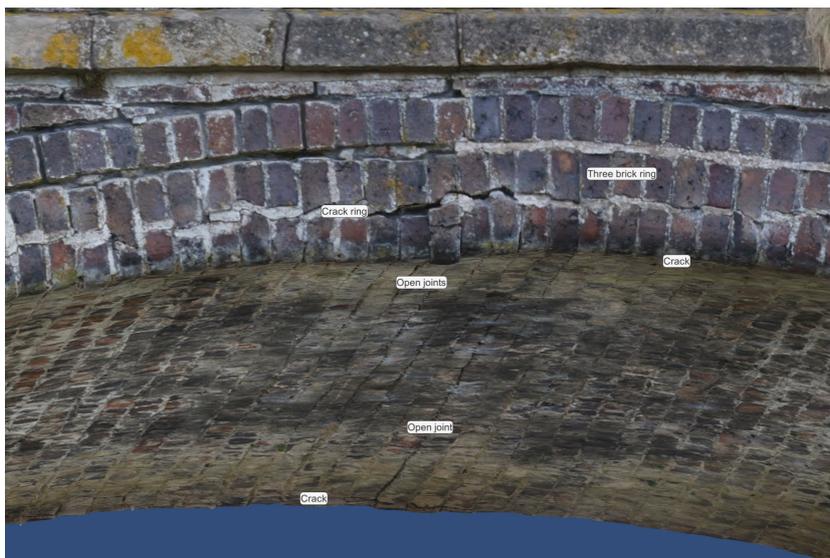
Figure 33: A closeup of the annotations near the crown.

First, the closeup in figure 33 shows that the annotations are held in 3D relationship. They are designed to be readable on screen and not to scale with the model as you zoom in.

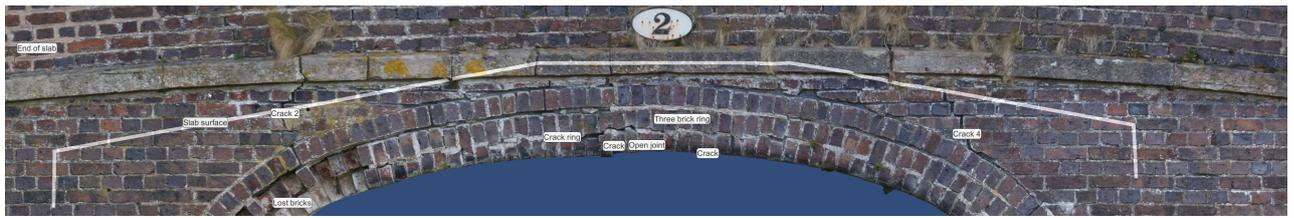
We can project the slab surface to the elevations using planes, and mark its location for ease of reference with line annotations, as shown in figures 34 and 35.

Figure 34: Western face showing extent of slab

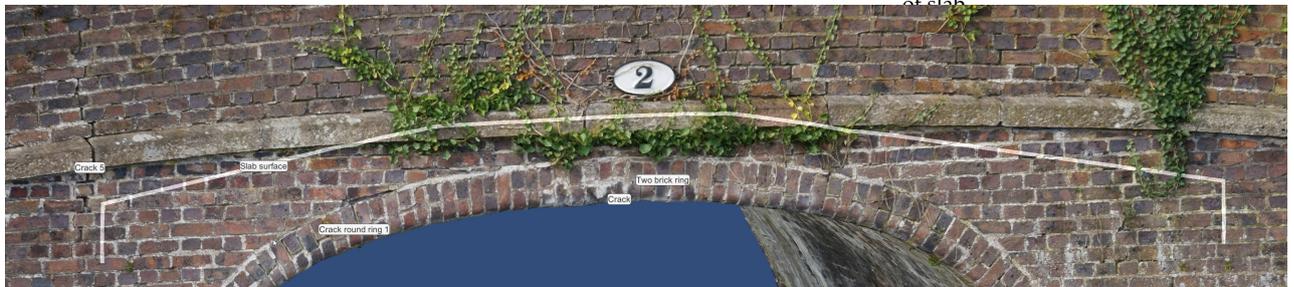
Figure 35: Eastern face showing extent of slab

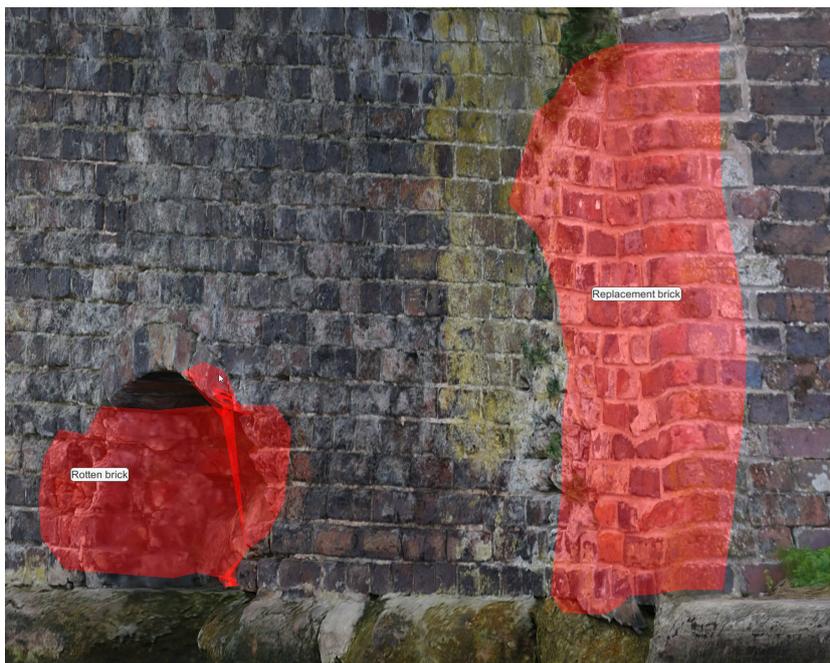
Transparent tints can be applied to indicate the extent of any detail being noted (figure 36). This, too, is a 3D effect, wrapping round the edge of the arch and into the hollow in the centre of the abutment. That is, perhaps, clearer if we turn the abutment to look from further under as in figure 37.

Figure 36: Tinted areas can be used to emphasise concerns, construction details, work required, and so on.
